Smoke and Dye Testing Summary

High Level Sewershed

Test ID	Test Type	Date Inspected	Company / Super.	Blower MH	Ground Condition	Notification Made?	Total Length
S1028-151	Smoke	4/13/2009	ADS/TM	S15C_014MH	Dry	Yes	2,077.68

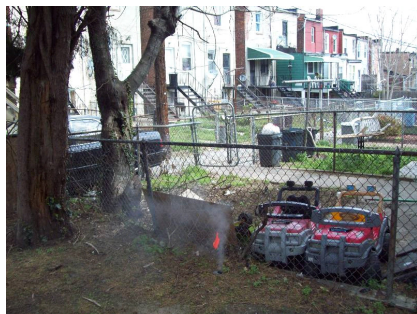
Picture \S1028-151-OB01-P01.jpg

Source Cleanout

Location Yard - back

Comments Smoke from cleanout in back yard near fence.
2638 Laurretta Avenue

Comments Back of house, 2638 Laurretta Avenue

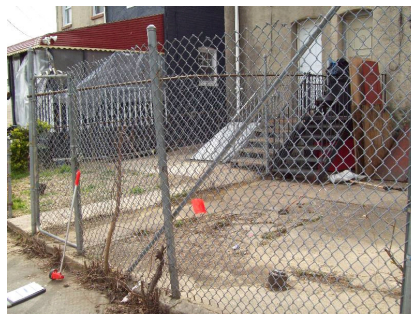
Picture \S1028-151-OB02-P01.jpg

Comments Smoke from cleanout on back patio. 2608 Laurretta Avenue

Comments Back of house, 2608 Laurretta Avenue

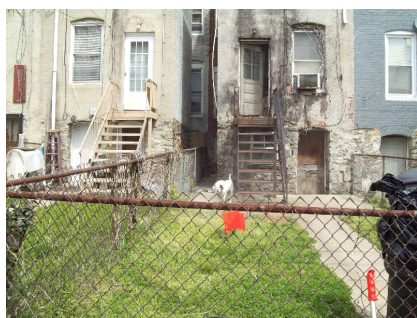
Picture \S1028-151-OB03-P01.jpg

Source Cleanout

Location Yard - back

Comments Smoke from cleanout in back yard. 2665 Edmondson Avenue

Comments Back of house, 2665 Edmondson Avenue
